# Manhole Inspection Summary

Manhole # S13KK1016MH

Insp Date: **11/28/06 1:41 PM**

**Location** Address: **2826 OAKFORD AVE**

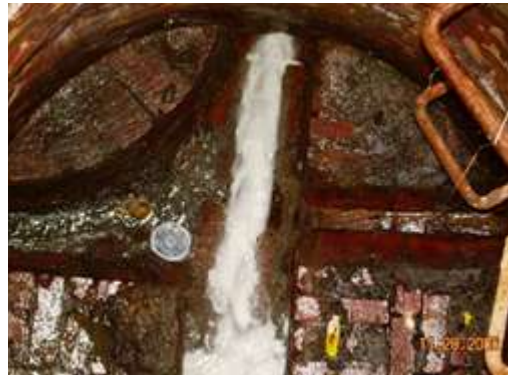
Top View

Corroded and missing steps. Bench debris.

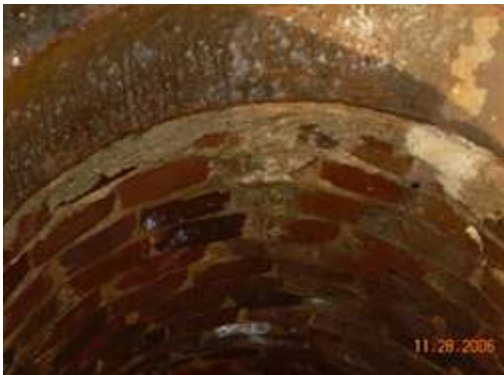
Defect

☒ **Leaks**

Condition: ☐ Sound ☐ Cracked ☐ Root Intrusion ☐ Loose Brick ☒ **Deteriorated**

Infiltration: ☐ None ☒ **Joint** ☐ Cracks ☒ **Mortar** ☐ Roots ☐ Wall

Frame leaks. Adjustment deterioration and infiltration.

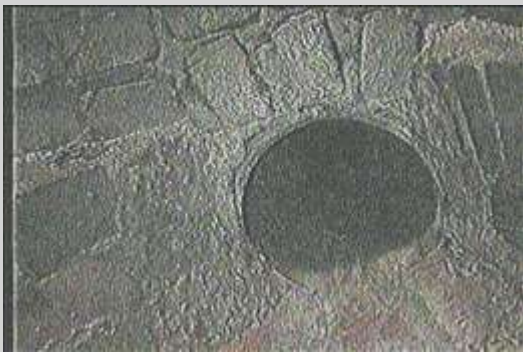
### 8 in. Circular Gravity Sewer Pipe Out @ 12 O'Clock

Barrel deterioration and infiltration. Channel deterioration.

Infiltration: **Evidence** Pipe Seal Cond: **Cracked**

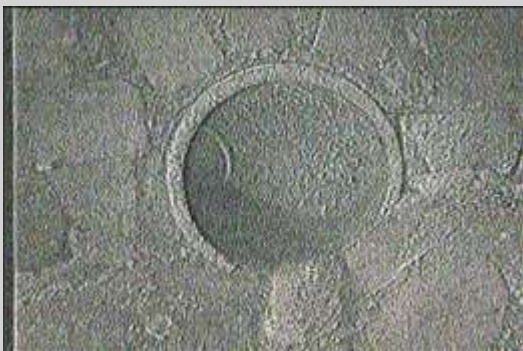
### 6 in. Circular Gravity Sewer Pipe In @ 3 O'Clock

Infiltration: **Evidence** Pipe Seal Cond: **Cracked**

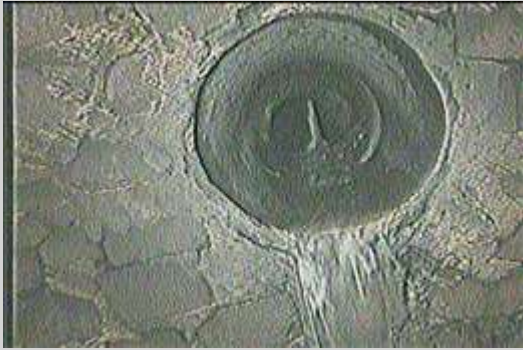
Pipe In @ 5 O'Clock

Infiltration: **Evidence** Pipe Seal Cond: **Cracked**

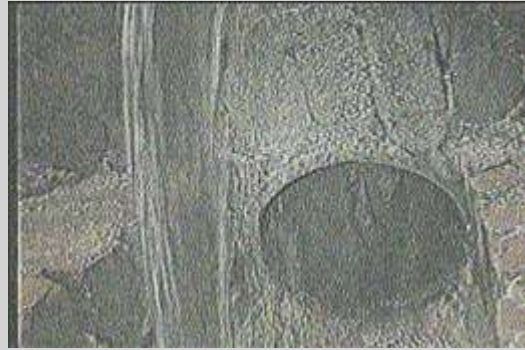
Drop In @ 5 O'Clock

Drop Condition: **Clogged**
